## Queens Grant Horizontal Propoerty Regime *Hilton Head Island, SC*

Report #: 36269-1  
Beginning: November 1, 2023  
Expires: October 31, 2024

# RESERVE STUDY Update "With-Site-Visit"

June 26, 2023

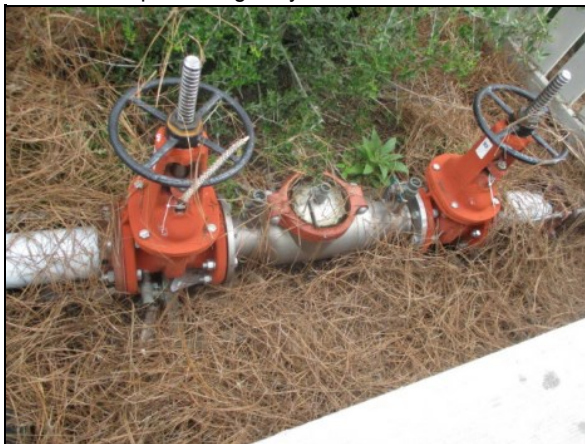
Comments: Most of the backflows have been replaced recently. Reportedly up to \$10,000 per backflow. These backflow systems have had relatively short useful lives compared to most systems we deal with. We have adjusted the price and useful life of this component. Backflows help prevent contaminated or dirty water from flowing back into the clean water supply. They are very important for the community and should be inspected regularly to confirm there are no hidden issues.

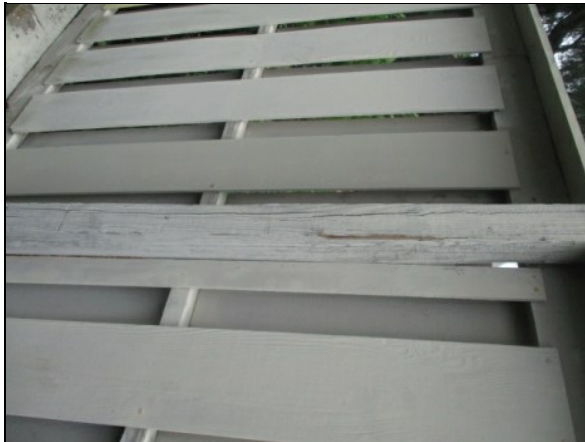
Comments: The fence surfaces were in fair condition and mostly clean. Some boards and columns were older and more weathered than others. Regular uniform, professional paint or sealer applications are recommended for appearance, protection of wood and maximum design life. Repair as needed and clean prior to application. Plan for regular applications as shown below. Repair/paint cycles should be coordinated with eventual fence replacement.

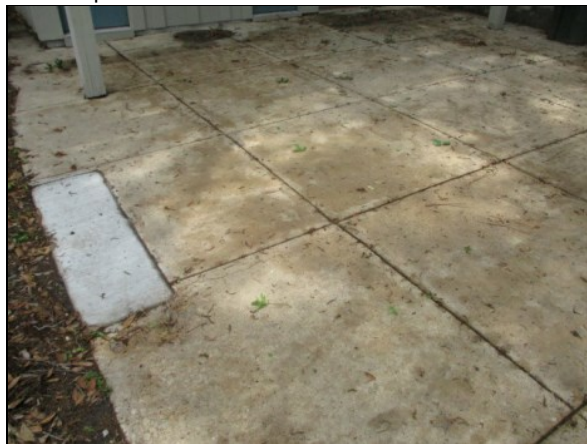
Comments: This patio is in fair condition overall. Moderate weathering has occurred since our first visit. Repairs are expected to occur as needed. Full replacement not expected to occur at this time.
