## Queens Grant Horizontal Propoerty Regime *Hilton Head Island, SC*

Report #: 36269-1  
Beginning: November 1, 2023  
Expires: October 31, 2024

# RESERVE STUDY Update "With-Site-Visit"

June 26, 2023

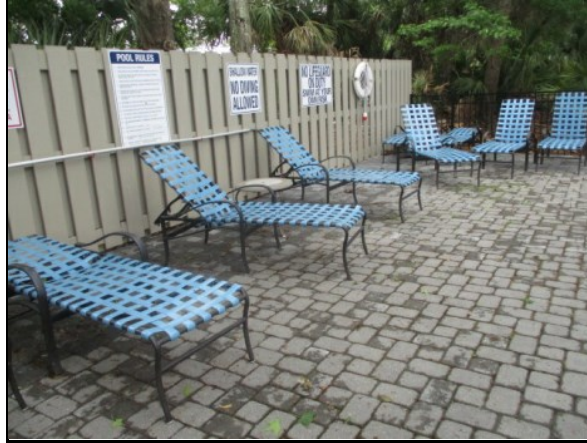
**Comp #: 2763 Pool Deck Furniture - Replace****Quantity: (36) Pieces**

Comments: Pool deck furniture is fairly new and overall in pretty good condition. Pool deck furniture determined to be in good condition typically exhibits minimal or no signs of aging, such as surface wear, chipped or rusted framework, etc. Pieces are consistent in style and condition and appropriate for the standards of the property. (24) lounge chairs, (8) drink tables, and (4) chairs were counted during our inspection. We recommend regular inspections and repair or replacement of any damaged pieces promptly to ensure safety. Protected storage of furniture when not in use can help to extend useful life. Best practice is to replace all pieces together in order to maintain consistent style and quality in the pool/recreation area. Individual pieces can be replaced as needed each year as an Operating expense. Costs can vary greatly based on quantity and type of pieces selected for replacement. Funding recommendation shown here is based on replacement with comparable number and quality of pieces.

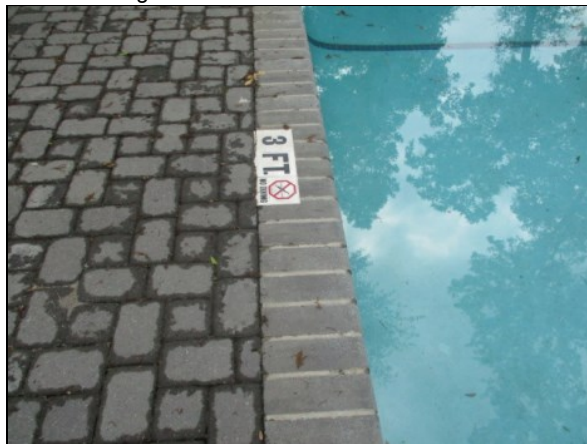
**Comp #: 2767 Pool Coping Brick - Replace****Quantity: Approx 120 LF**

Comments: Swimming pool brick coping determined to be in good to fair condition typically exhibit a generally smooth, consistent appearance with no noticeable chipping or cracking of the surface. Little or no staining or discoloration. Waterline tile/finish is clean and attractive with no cracked or missing tiles.

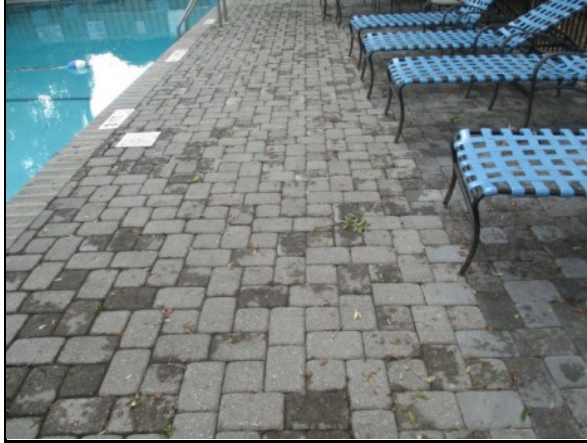
Comments: Approximately 220 GSF of pool paver decking was added since our previous inspection. Added pavers are the same style as the original. The added surface should not extend the remaining useful life. This pool deck was in fair condition. Paver pool decks determined to be in fair condition typically exhibit some amount of minor displacement, lifting, and tripping hazards, most often in high-traffic areas. Signs of wear and age are evident, but not advanced. Overall appear to be aging normally. Paver decks should have a long useful life under normal circumstances. Should be pressure-washed as needed to preserve appearance and remove stains, chemical residue, etc. Replacement costs can vary depending on style of pavers chosen, configuration of deck, etc. We recommend budgeting for replacement at the approximate interval shown here.

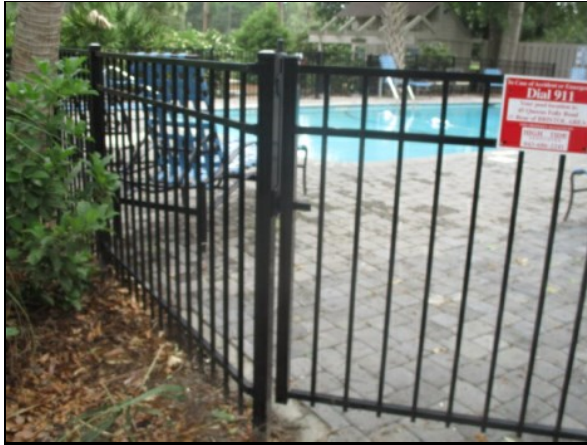
**Comp #: 2771 Pool Fence - Replace**

Comments: The original chain-linked pool fencing was replaced with an aluminum fence. Some linear footage was added to reach the perimeter of the extended pool deck. Pool fencing was determined to be in good physical/structural condition and is stable and upright, with no signs or reports of damage or required repairs. All components and hardware appear to be in serviceable condition with no unusual or advanced signs of wear or age. The fencing is in good aesthetic condition. As a routine maintenance item, the fence should be inspected regularly and repaired as needed to ensure safety. Periodically clean with an appropriate cleaner and touch up paint as needed in between regular paint cycles. When evaluating replacements, be sure to comply with any applicable building codes. Gates and locks should be inspected to make sure they close and lock properly. The faulty perimeter around a pool area can expose an Association to significant liability risk. When possible, replacement should be coordinated with other projects, such as pool deck projects, other fencing/railing work, etc.

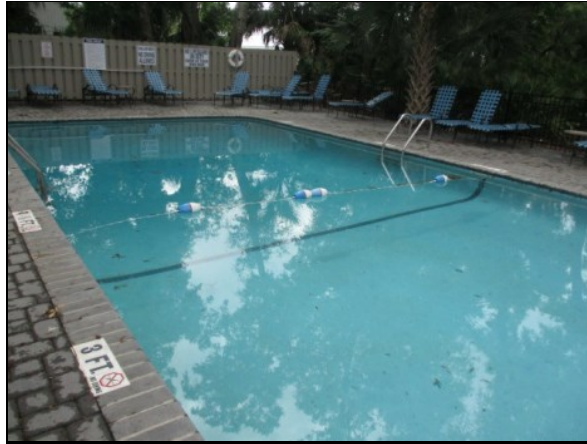
Comments: There were no issues reported with the pool in regards to leaking or water retention. Overall it appeared to be in fair condition overall. Approximately 800 GSF footprint area with 120 waterline/perimeter length. Swimming pools determined to be in good to fair condition typically exhibit a generally smooth, consistent appearance with no noticeable chipping or cracking of the surface. Little or no staining or discoloration. Waterline tile/finish is clean and attractive with no cracked or missing tiles.

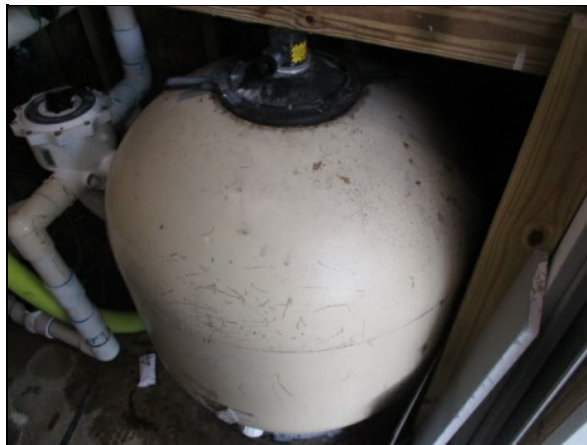
**Comp #: 2779 Pool Filter - Replace****Quantity: (1) Filter**

Comments: There was reportedly a new filter on the way at the time of inspection. Pool filter did not have any issues reported at this time. Pool vendor should inspect regularly for optimal performance and address any repairs or preventive maintenance as needed. Life can vary depending on location, as well as level of use and preventive maintenance. Plan to replace at the approximate interval shown below.

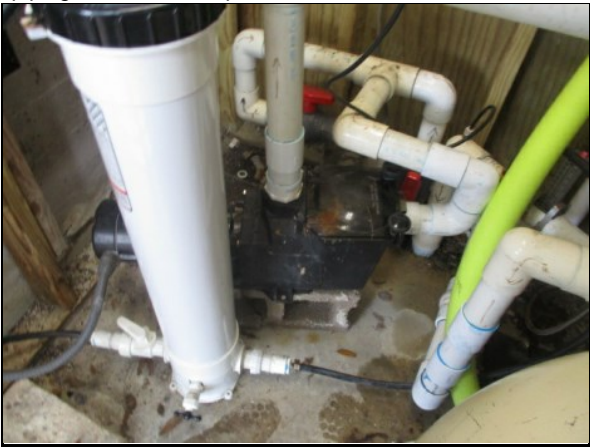
**Comp #: 2783 Pool Pump - Replace**

Comments: Pool pump was running during our visit with no noticed leaking issues. Pumps should be inspected regularly for leaks and other mechanical problems. Cost shown is based on replacement with the same type and size unless otherwise noted, and includes small allowance for new piping/valves/other repairs as needed.
